# Durability Issue for the Emperor Fasiladas Royal Palace in Gondar (Ethiopia)

*Eskinder Desta Shumuye and Gashaw Assefa Bezabih*

## Abstract

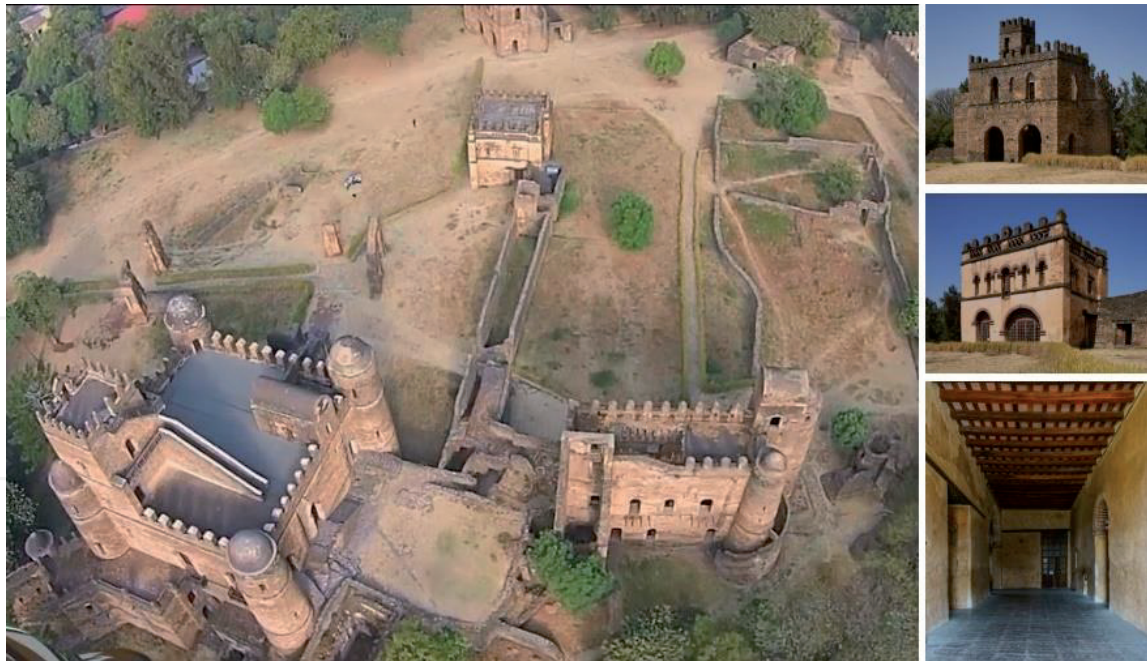
**Figure 1.**  
*Fasil Ghebbi palace [29].*

According to Eskinder [4] method of construction for the Royal palace walls were by stone masonry. The abundant type of construction materials which were used during the construction of the Royal Palace was mainly by Basaltic Rock and Pumice with a Local name of “Beha Dingay [ባሃ ደንገይ]”; which is transported from “Kuskuam mariya” and “Azezo,” respectively. The type of binding material which was used during the construction of the Royal palace was also identified as lime (CaO). It is clear that lime and gypsum have always been functionally important materials in building, and in the light of recent archeological investigation, it appears that these materials are equally important historically. And they are important not only in building history but in the general history of mankind [5] (**Figure 1**).

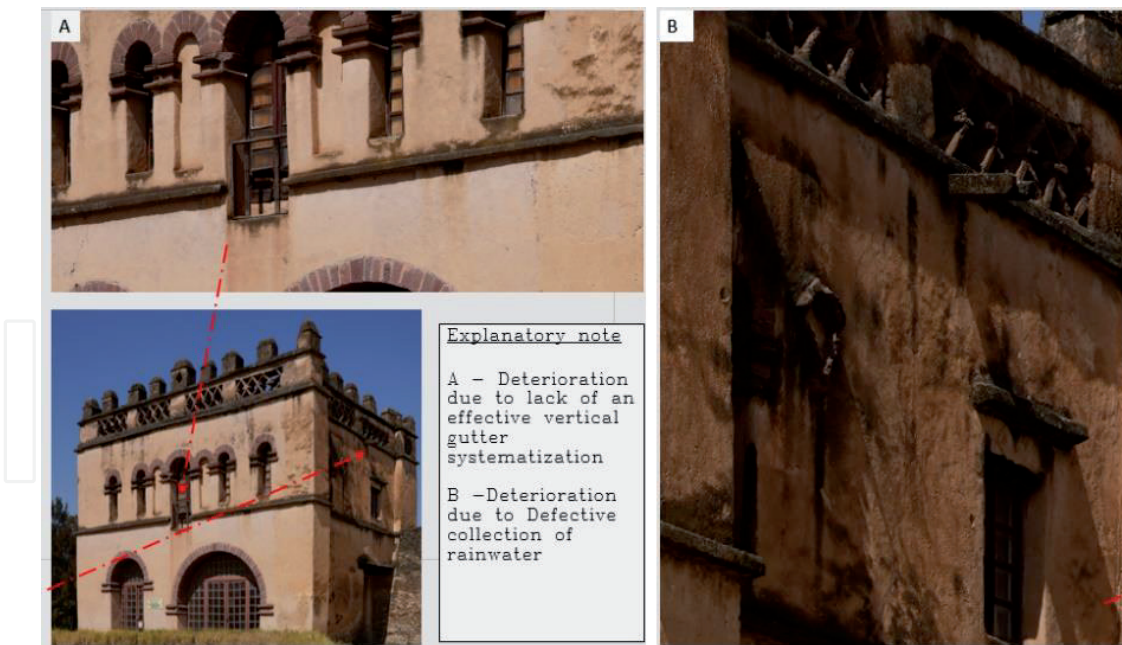
The soil between groundwater level and earth surface holds water by capillarity where this event is called as “surface water” or “capillary water” that cannot be removed by using any drainage system. The humidity rising up the building can cause serious damages on the structure [11]. According [Nigussie] to The groundwater around Gondar city can be found at a depth between 6 and 8 meters [12] consequently the groundwater at this depth cannot affect the durability of the structure (**Figure 2**).

**Figure 2.**  
The effect of improper rainwater removal on the face of the wall [29].

damaging manifestation when this rainwater vaporizes. In case of the Fasil castle, geomembrane was used to solve the effect of rain water dispersion through the wall cracks. However, the application is inadequate for the main palace. Two variables are important from the viewpoint of the damage caused by moisture: dew point and relative humidity of air.

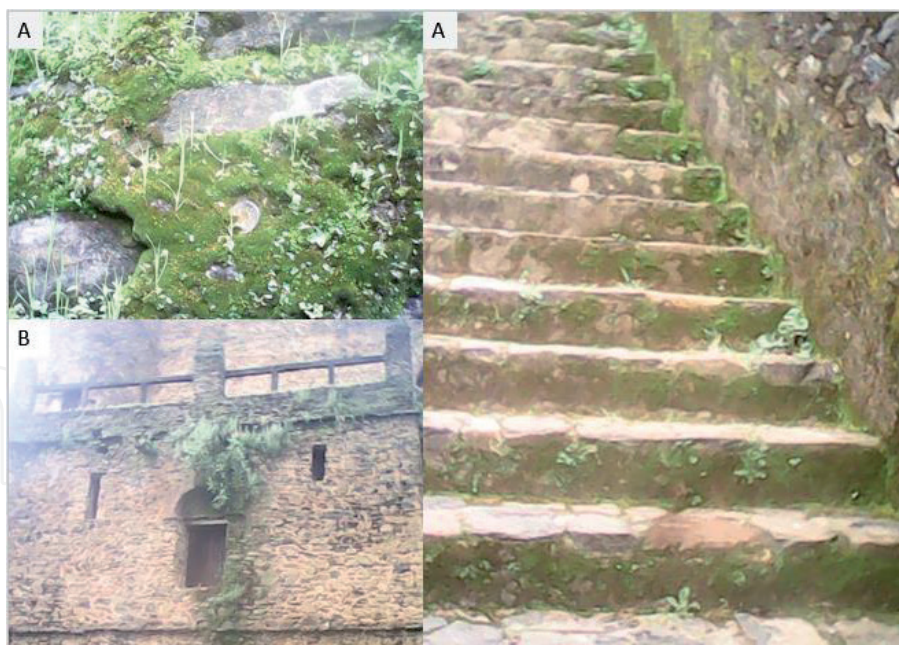
**Figure 3.**  
*The progressive biodeterioration processes on the surface of building materials: algae constitute the medium for the growth of fungi that pass through the building material by means of their hyphae. Dense formations of herbaceous plants [A] vascular plants [B] mosses and algae [source; Eskinder Desta].*

Biological colonization is affected by substrate characteristics both physically and chemically. Due to the surface roughness of the masonry wall, algal cells can easily adhere to rougher surfaces, yet algae have the ability to extend on such surface. Microorganisms flourishing on the surface lead to microbiological deterioration and chemical deterioration. In most walls of the palace, which is exposed to the moisture; microorganism is observed on the facades of buildings, consist of bacteria and algae (including cyanobacteria), lichens and protozoa. Because of their resistance to high temperature and desiccation, lichens and vascular plants are generally play a role in the biodeterioration of the binding material of the masonry wall of the palace.

Bio-deterioration of the binding material occurs due to alive organisms or the products of its metabolism. The process of colonization of a mortar is favored by its characteristics (porosity, mixture and roughness). These properties facilitate the retention of water in the binding material and the consequent growth of algae and cyanobacteria. As shown in **Figure 3**, it is the common durability issue in the royal

palace. For instance, biodeterioration of mortars of the Mosaics of Italica and some other Spanish archeological sites (Baelo Claudia, Medina Azahara) solved by the development of the biocide mortar, the biocide is adsorbed in sepiolite avoiding a quick leaching and increasing the effectiveness [18].

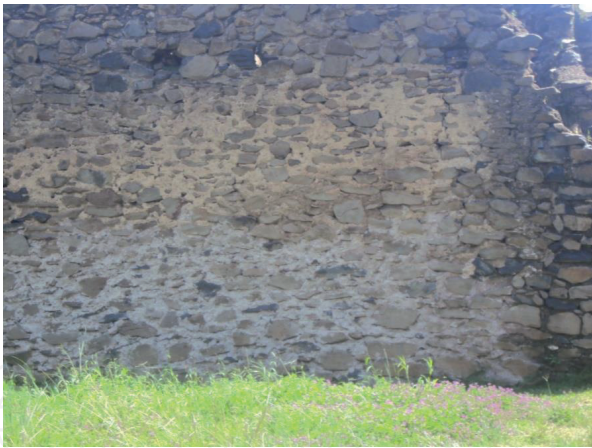
**Figure 4.**  
*A widespread lack of binding mortar in between the stone masonry [source; Eskinder Desta].*

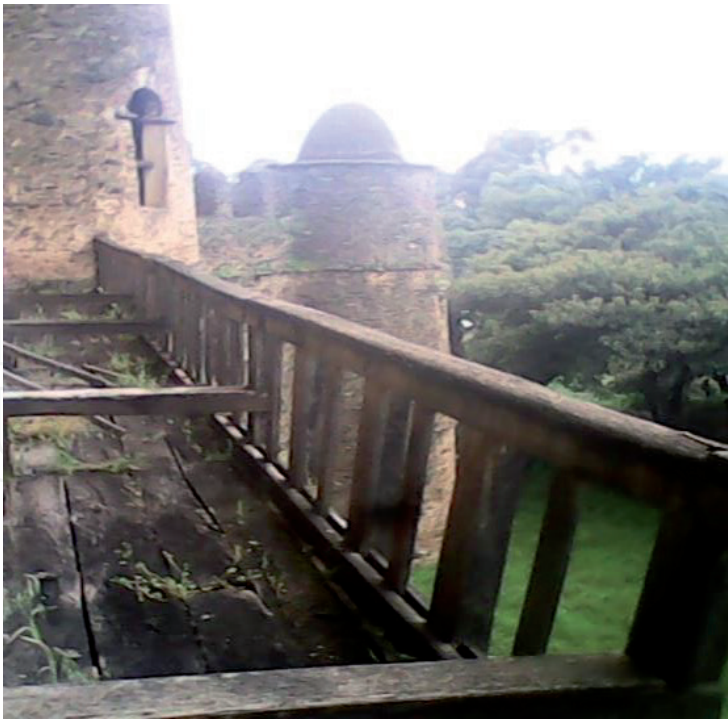
**Figure 6.**  
*Active durability issue due to the presence of grass and alga on the wood floor terrace [source; Eskinder Desta].*

The investigation commenced with a visual inspection of the internal and external palace wall. As shown in **Figure 6**, the damage appeared to intensify on the outside wall surface and building components compared with that of the internal wall surface. The visual examination was followed by measuring the slope deflection of the masonry wall as shown in **Figure 7c**.

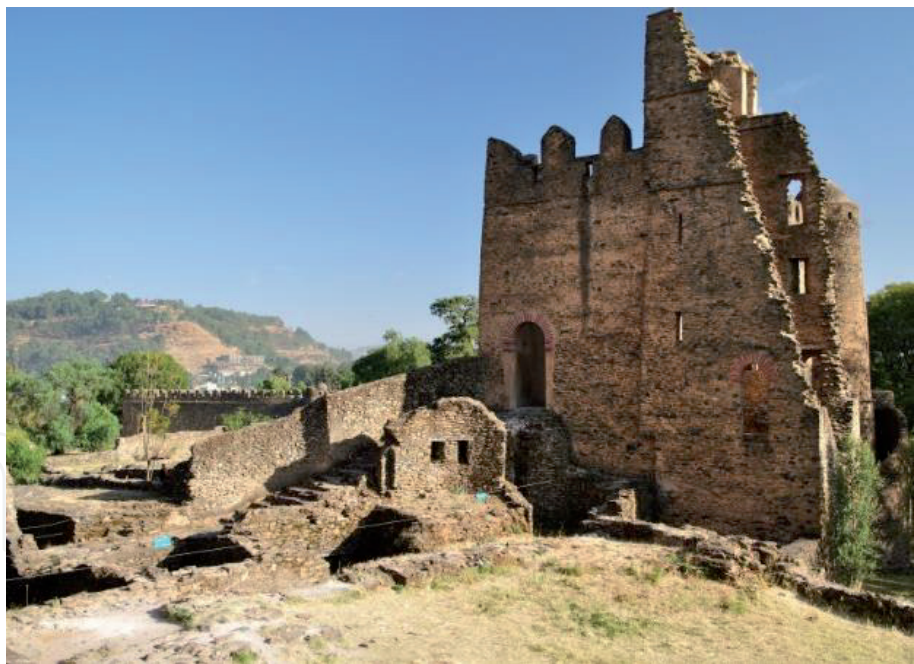
**Figure 9.**  
*Iyasu Castle Fasil at Ghebbi [29].*

Even if the seismic zonation of Fasil Ghebbi is safe but in there have been a major geological incident in the Fasil Ghebbi as reported by Briggs [29] Iyasu Castle was partially damaged by earthquake in 1704 and the ground floor collapsed under the British bombardment in world war II. **Figure 9** illustrates destructive effects the earthquake that occurred on the Fasil Ghebbi at Iyasu Castle in 1704.

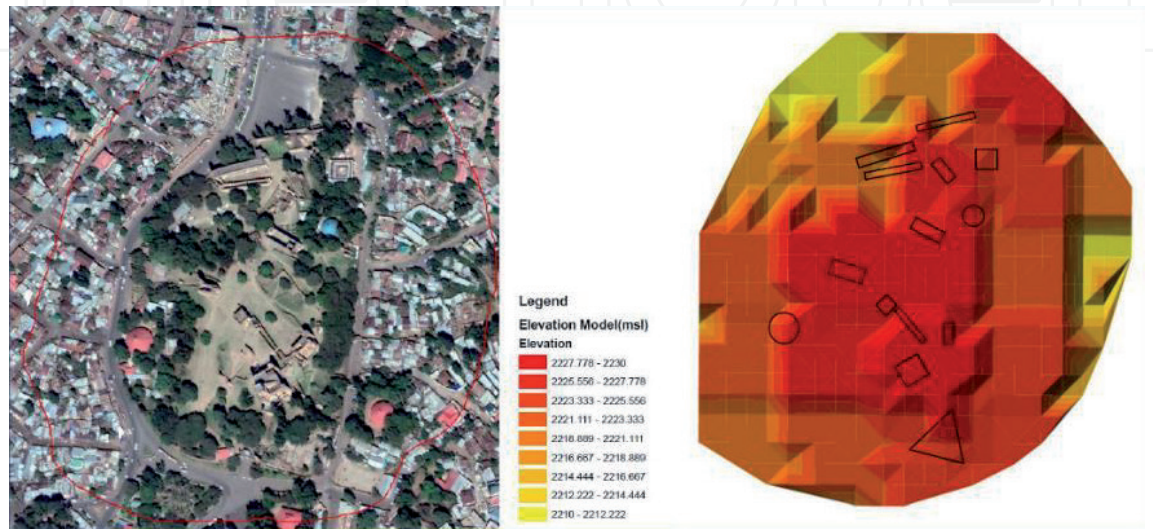
Krauss and Fischer [32] studied endangerment of the Palmyra to flooding using DEM and concluded that Temple of Bel lies on a locally higher area the tombs to the left are located mostly on the mid slopes but also remnants can be found in the endangered lower areas which is exposed to flooding. Using simple digital elevation model generated using *Arc GIS* utilizing elevation obtained from Google Earth it can be seen in **Figure 10**, that most of the structures in the Fasil Ghebbi are situated on the upper elevation therefore the risk of flooding during peak rainfall is minimal.

**Figure 10.**  
*Fasil Ghebbi digital elevation model.*

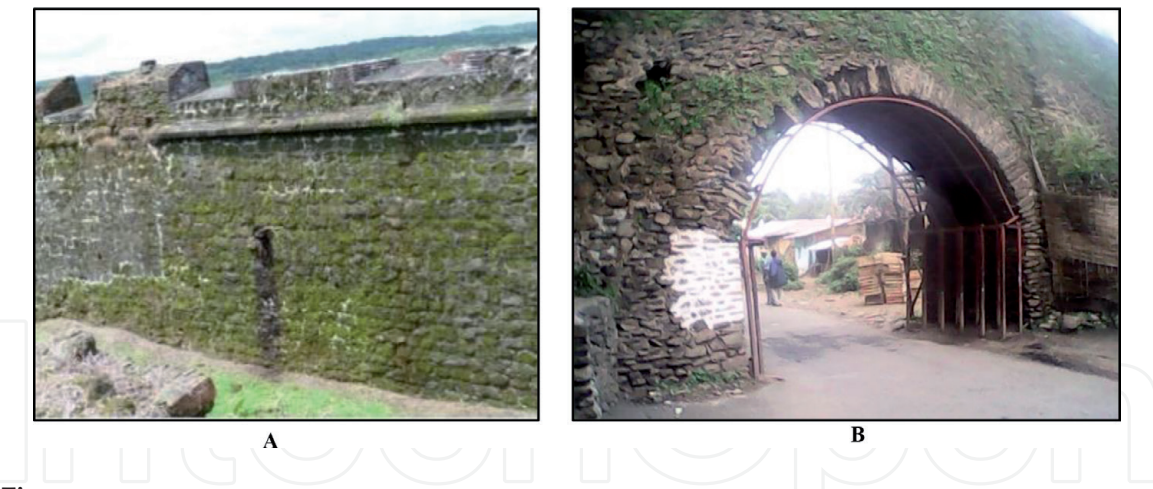
**Figure 11.** Biological growth at Fort San Lorenzo (Panama); source and Fasil Ghebbi [source; Eskinder Desta].  
A. Biological growth at Fort San Lorenzo (Panama). B. Biological growth at Fasil Ghebbi.

Climate and biological effects may include changes to lichen colonies on buildings, spread of existing and new species of insects, increase in mould growth. According to UNESCO climate change and world heritage report [31] these factors may cause changes in appearance and collapse of structural timber and timber finishes. As an example; **Figure 11** shows the biological growth at Fort San Lorenzo [33] and Fasil Ghebbi [4] (**Figure 12**).

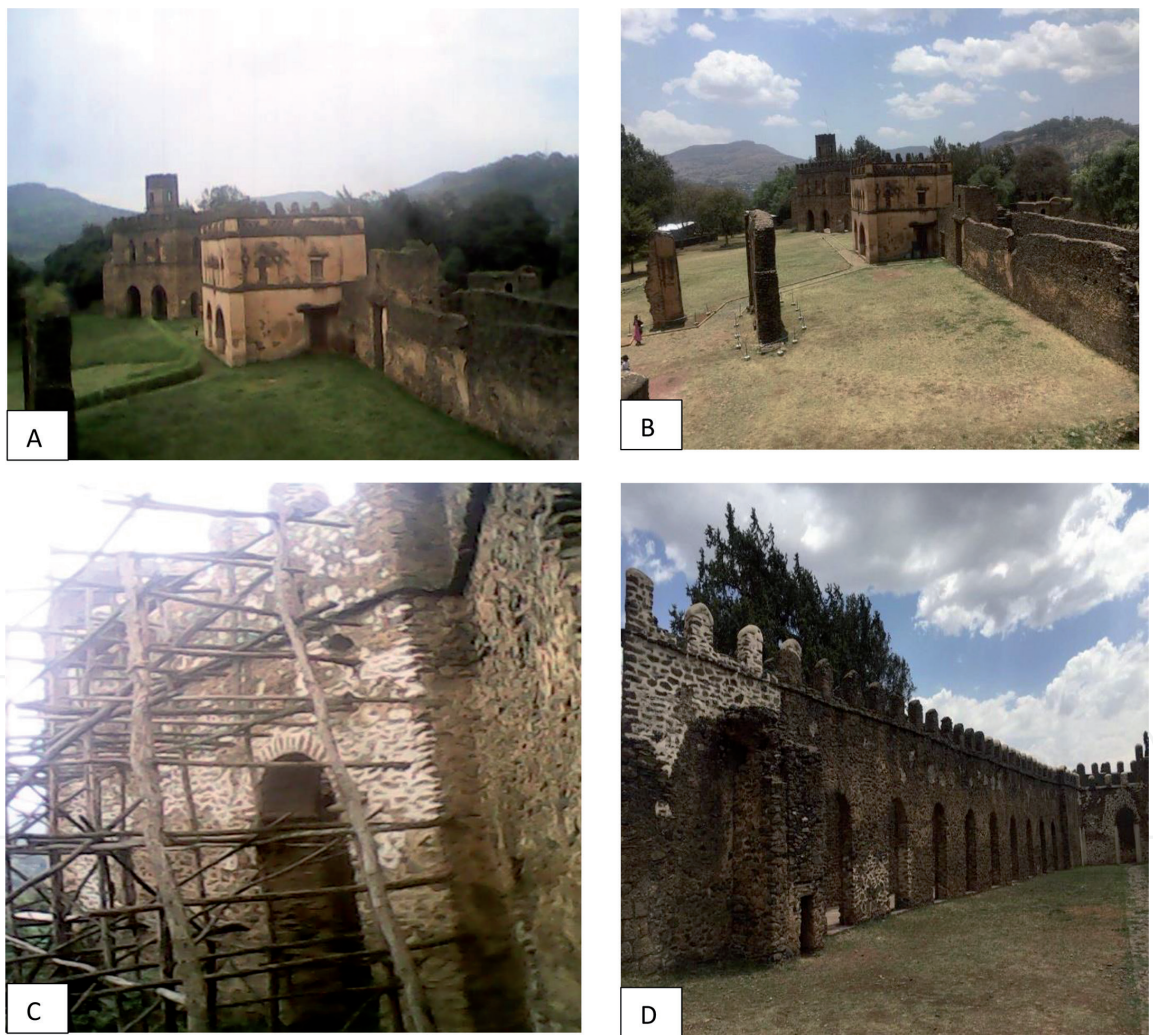
**Figure 12.** Some selected spots inside the royal palace before and after restoration. (A and C): in 2015; (B and D): in 2019 [source; Eskinder Desta].
